## *Curtain Grouting Stops Leaks*

### **Facilities Management for College Campus Credits Special Grouting Technology with Ending Recurring Groundwater Infiltration**

*Fluctuations in Water Table Level No Longer a Problem*

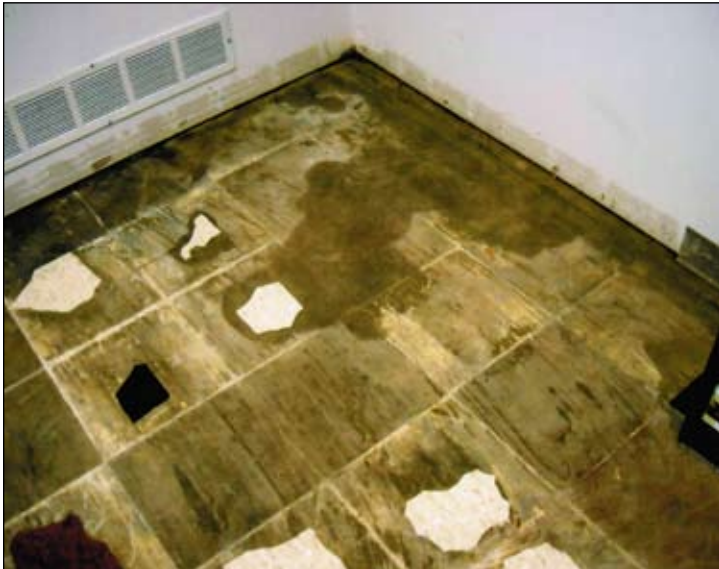
Basement infiltration affected the entire lower level of a college classroom building. A tissue dropped at the wall line would flow toward the center of the floor.

However, the infiltration “came back with a vengeance” about a year later, this time affecting the entire lower level of the building. Water flow could be discerned around the footing line, and carpeting in several areas was extremely saturated. When the carpet was removed, the water continued coming in, reaching 1/4 in. to 1/2 in., and popping floor tiles loose.

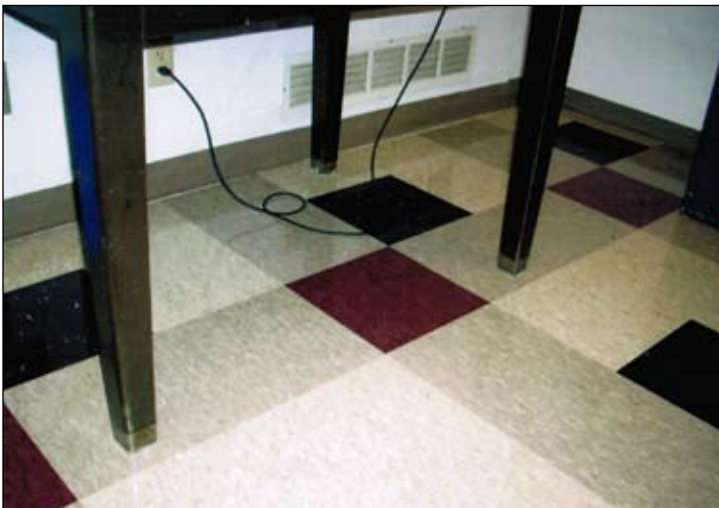
The curtain grouting contractor guaranteed he would stop the water in the classroom building. He did, in only four days, and in time for the new school term.

Bredvick said the chemical grout from Avanti is a polymeric gel type, and includes a catalyst. It was injected through hundreds of holes drilled through porous concrete, spreading into a “curtain” outside the previously leaking walls, that came back toward the walls to create a full mechanical lock.

“We didn’t have to do any excavating, nor did we have to worry about weather problems,” he noted. “The grout has a 35-40 second set time. It starts with the viscosity of water and then comes back and gels up. We drilled varying numbers of holes at each location, according to the size of the crack and other factors, into the cracks or on either side, starting at the bottom. By taking care to get it in the right places, we didn’t use more grout than was necessary.”

He said the grout was injected at 300-600 psi, with the hydraulic injection system capable of injecting up to 1000 psi. It features a 2-way, gravity-fed piston pump.

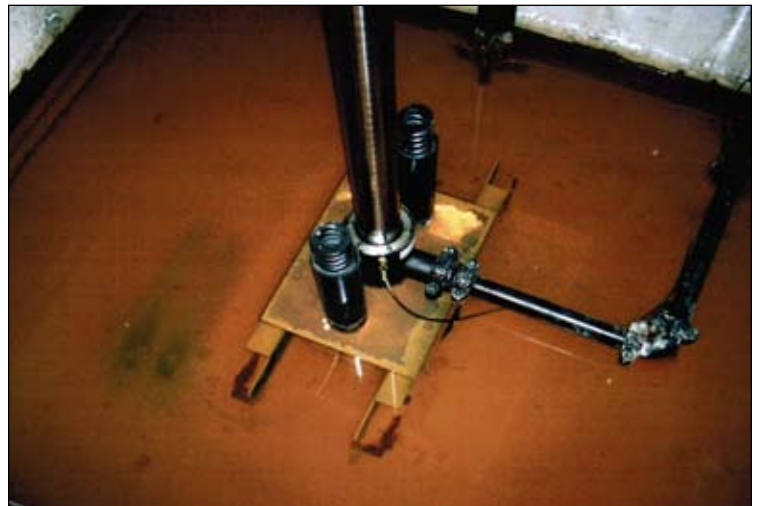
Elevator company had been unable to solve shaft flooding in campus building using their own personnel and resources.

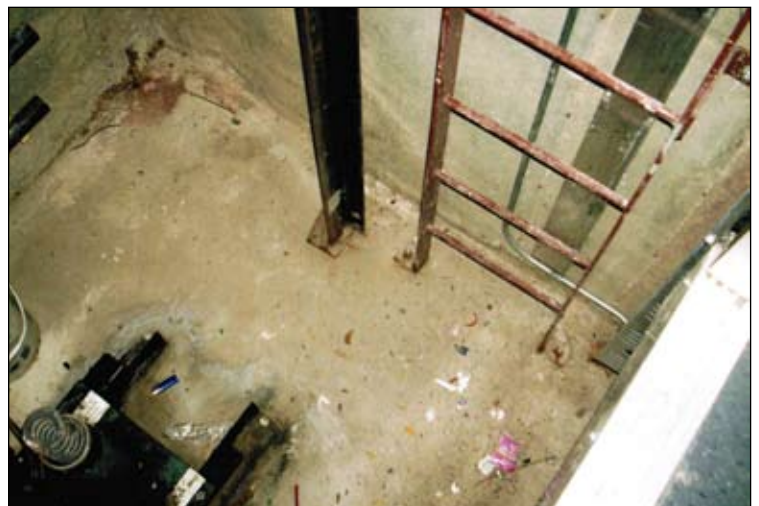
Curtain grouting contractor fixed shaft flooding within a day, and later also a similar problem in a mechanical room within a day.

“We had made numerous attempts to have the elevator company take care of it with their own folks, and had made no headway,” Allton recalled. “John came in and took care of the shaft within a day, and later also the mechanical room within a day.”
