Pool Water Quality News™

Special Ultraviolet(UV) Water Treatment Systems Provide Continuous, Cost-Effective Breakdown of Chloramines At Multi-Pool Facility

Enhance Facility Appeal While Reducing Costs For Chloramine Control

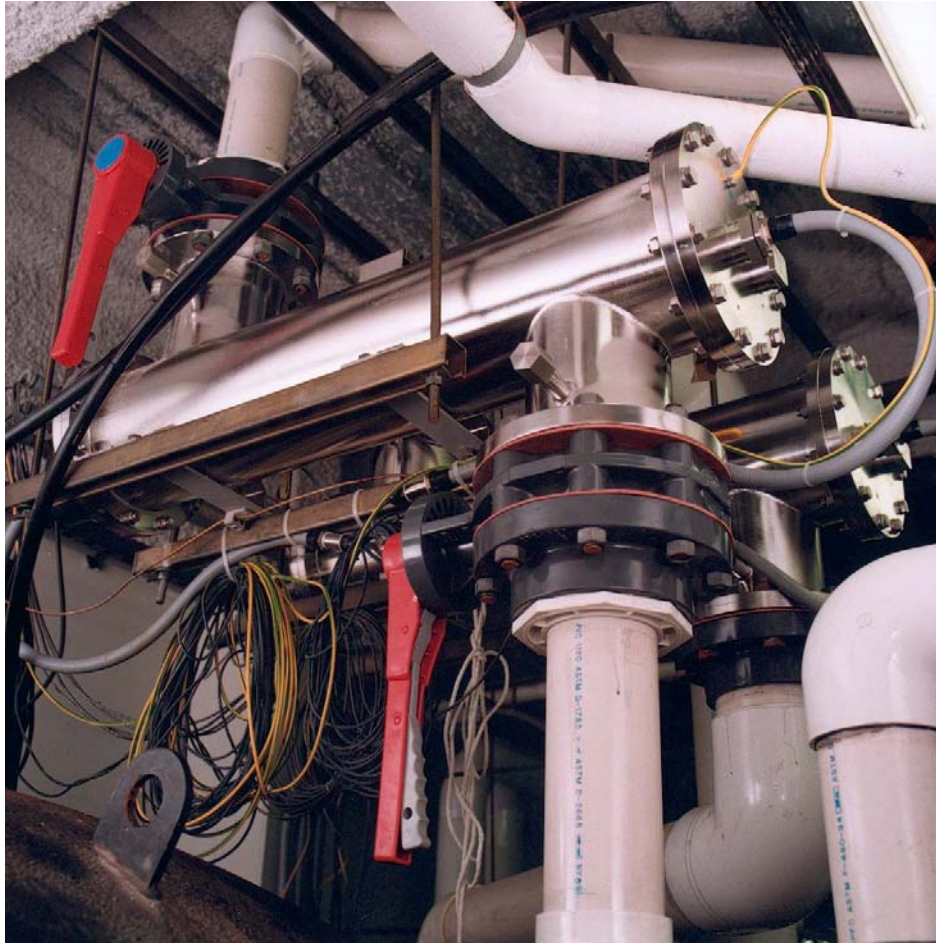
Photo #1:

Special ultraviolet water treatment systems for lap pool and therapy pool at The Summit in Kalispell, MT were deployed in adjacent installations to suit space convenience. Unit for lap pool typically treats water at 480 gal./min., reaching as high as 550 gal./min. during optimum filtration. Unit for therapy pool typically treats at 180 gal./min.

The UV system for the 75', 130,000-gal. lap pool treats water at a typical rate of 480 gal./min., and reaches as high as 550 gal./min. during optimum filtration. In the therapy pool, the typical rate is 180 gal./min., while the spa pool is treated at about 140 gal./min. Abel said the UV installations were easily handled by a plumber and electrician, requiring only "cutting into a pipe, putting the device in-line in its proper place, mounting an electrical control panel on the wall, and wiring it in."

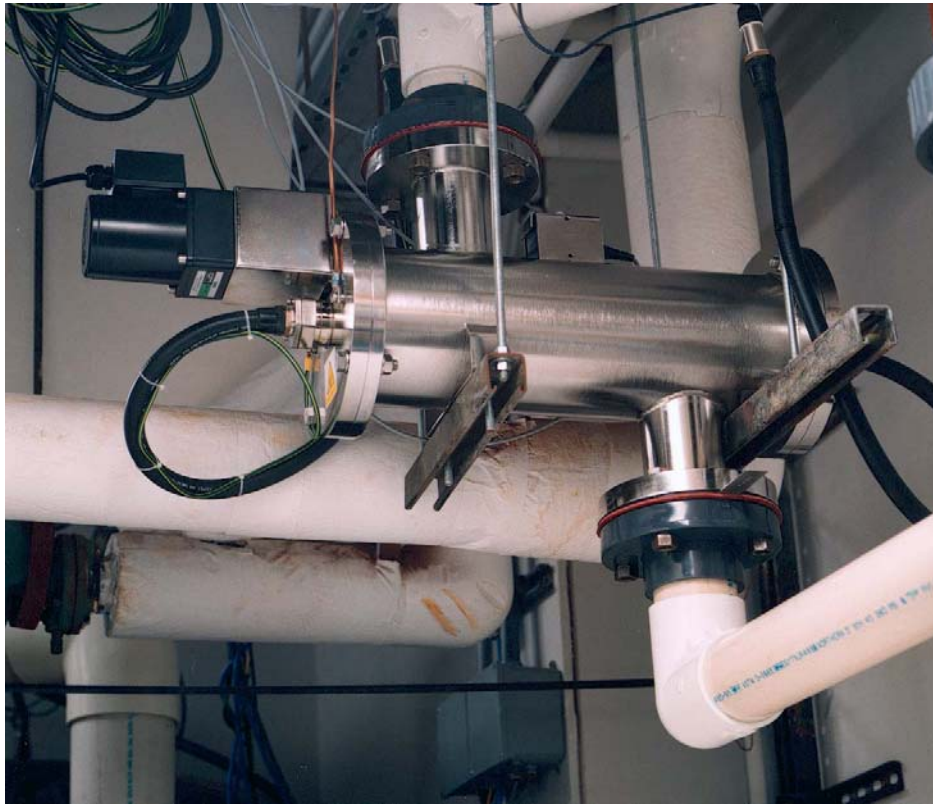
Photo #2:

Successful experience with installation of special ultraviolet(UV) water treatment systems for lap and therapy pools at The Summit in Kalispell, MT led to installation of third system for facility's spa pool. Unit there treats water at about 140 gal./min. All installations were easily handled by a plumber and electrician.

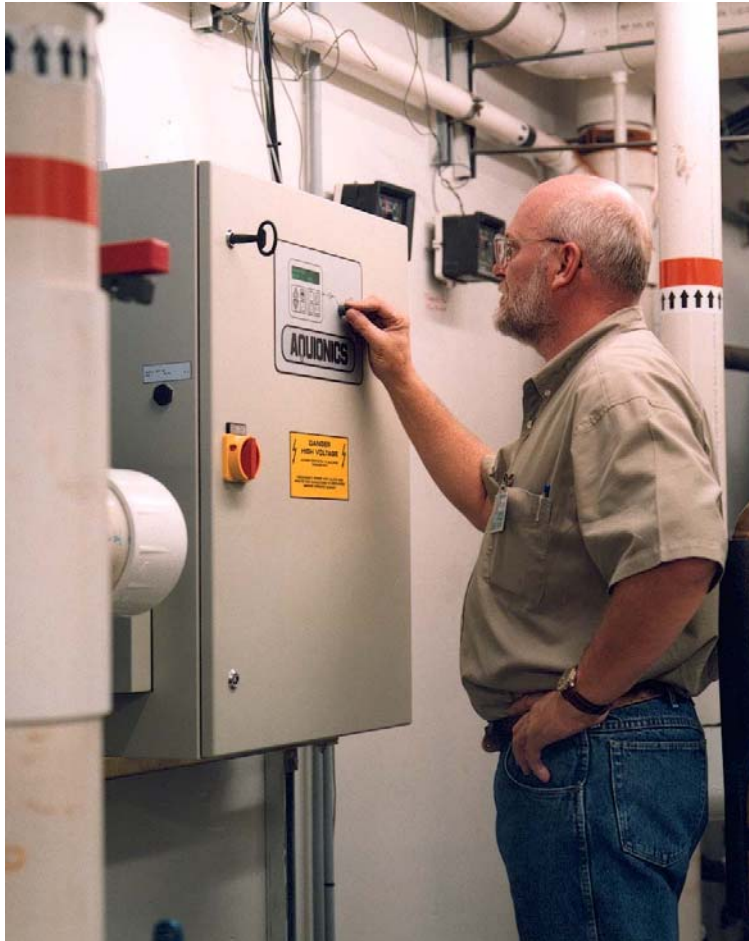
Photo #3:

Each of three special ultraviolet(UV) pool water treatment systems at The Summit in Kalispell, MT features its own control panel, with extensive performance data available for record keeping and/or sending to a remote location for continuous monitoring. Testing of pool water at The Summit for chloramine and total chlorine is performed with an ORP (Oxidation Reduction Potential) automatic reader, and manually through DPD (N,N-Dethyl -P-Phenylenediamine) 1A & 1B and DPD 3.

The company adds its systems are fully automated, and require a minimum of maintenance throughout the year. If continually run, lamps are said to require replacement annually, with staff capable of performing the task in fifteen minutes, with pumps remaining on. Its UV systems are readily integrated into an existing operation, with extensive performance data available for record-keeping and/or sending to a remote location for continuous monitoring.
